Guernica
Pablo Picasso
Technical Studies
Conservation–Restoration Department

Guernica

Technical studies

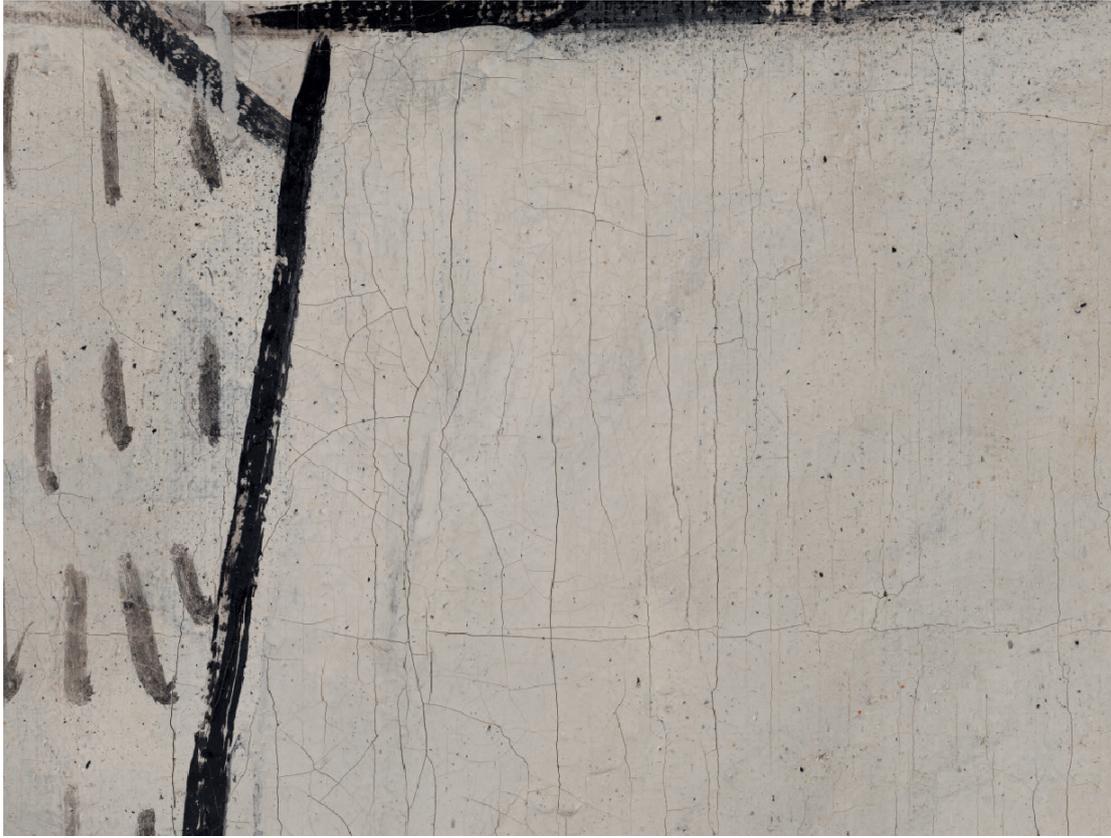
Through an in-depth analysis of the conservation state of the work, we can often observe alterations such as cracks, craquelure and micro-fissures (Fig 5). These deteriorations have occurred through the handling of the painting and the number of times it has been rolled for transportation over the years, a result of the touring exhibitions it participated in before hanging inside MoMA in New York.

Fig. 5. Details of the craquelure found on the horse's body.

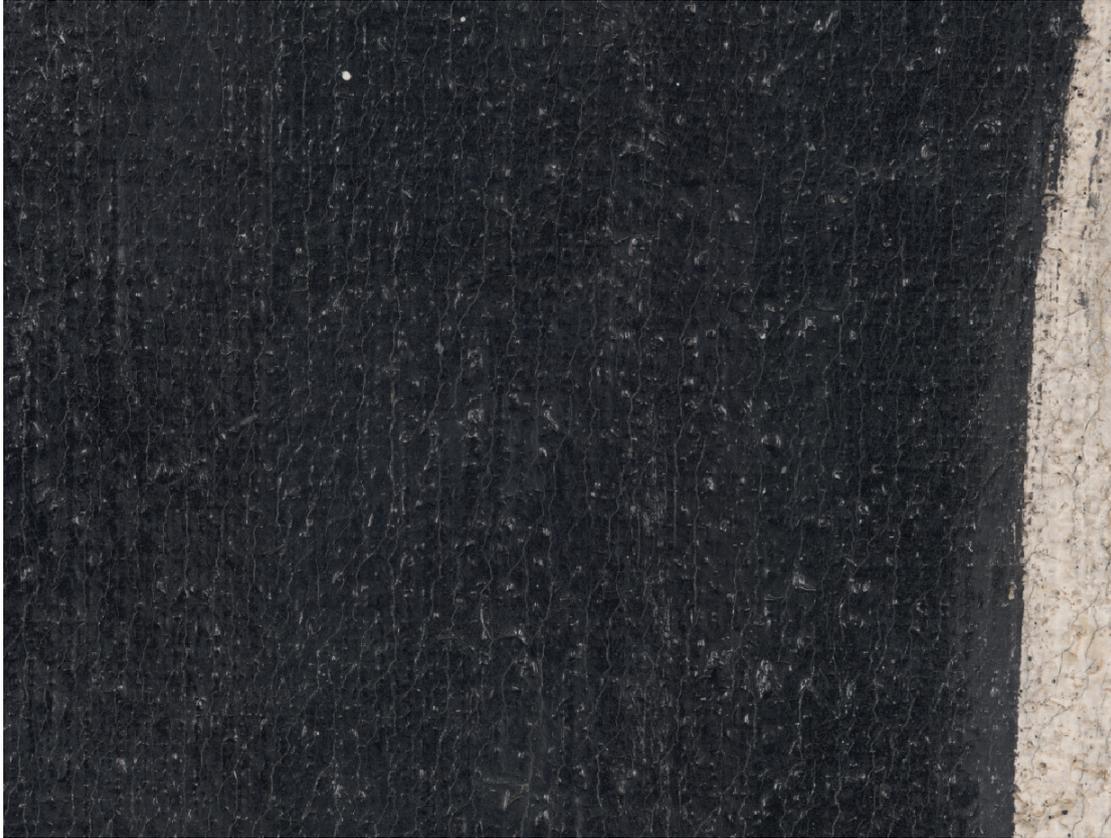
On certain dark areas of the work, widespread craquelure can also be discerned, generally affecting broad areas of the canvas. (Fig. 9).

Fig. 9. Detail of the micro-craquelure on the black paint.

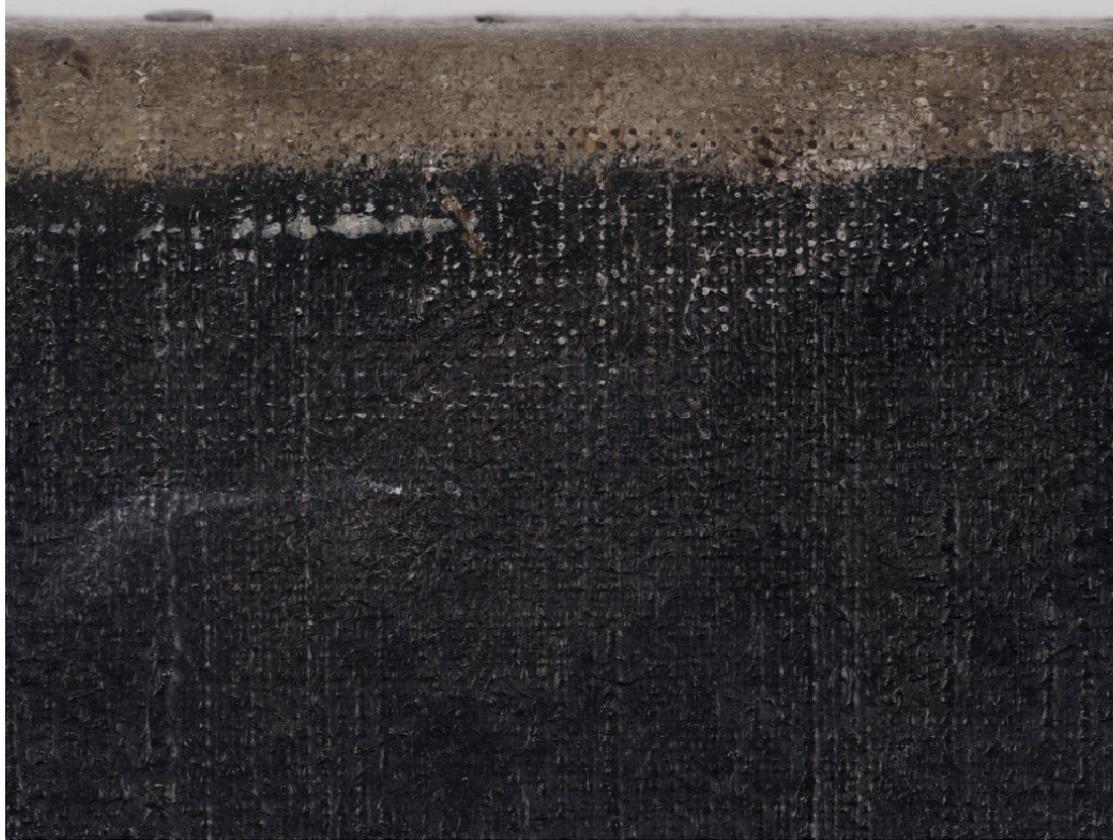
Another example of paint losses can be found at the top edge of the canvas, where we can see micro-losses, revealing the white background corresponding to the ground layer (Fig. 12).

Fig. 12. Details of micro-losses at the top of the work.

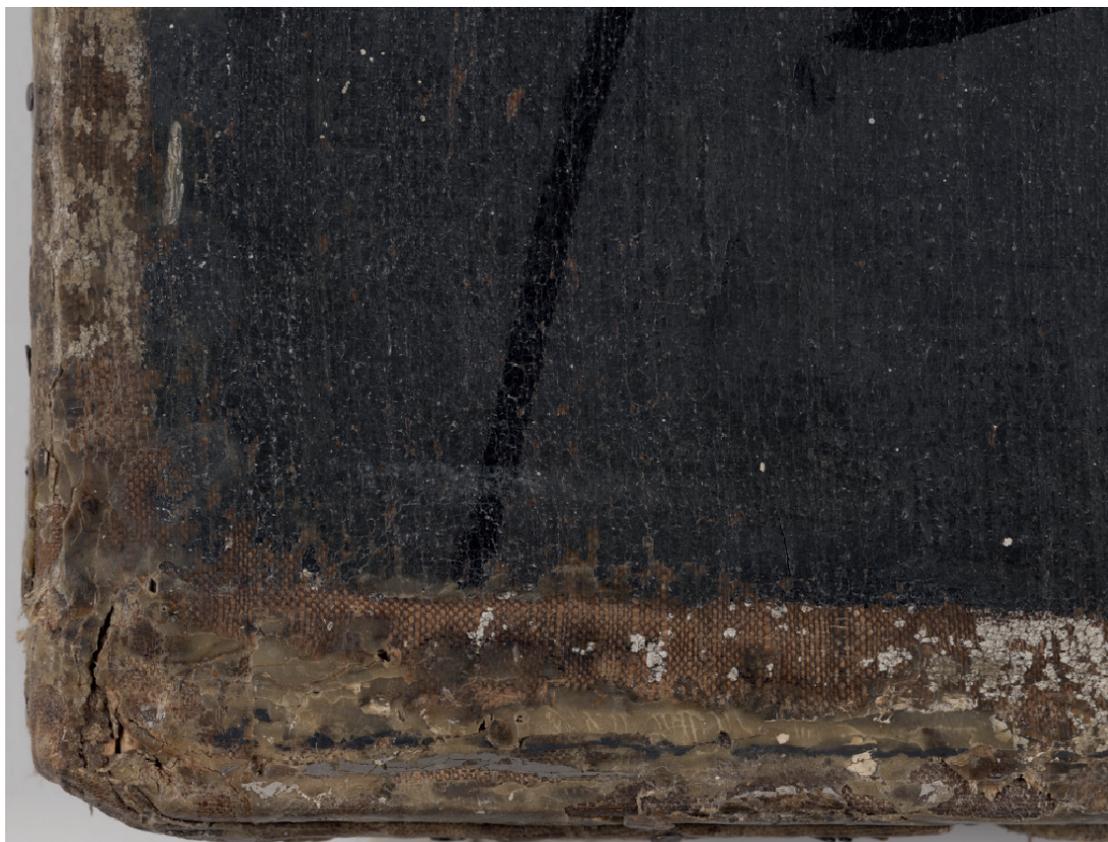
Furthermore, in the areas at the edge of the work, with the white ground layer, there is a considerable increase in the loss of materials, compared with the rest of the paint surface (Fig. 13).

Fig. 13. Close-up of the bottom left corner, where losses to the ground and paint layers can be observed.

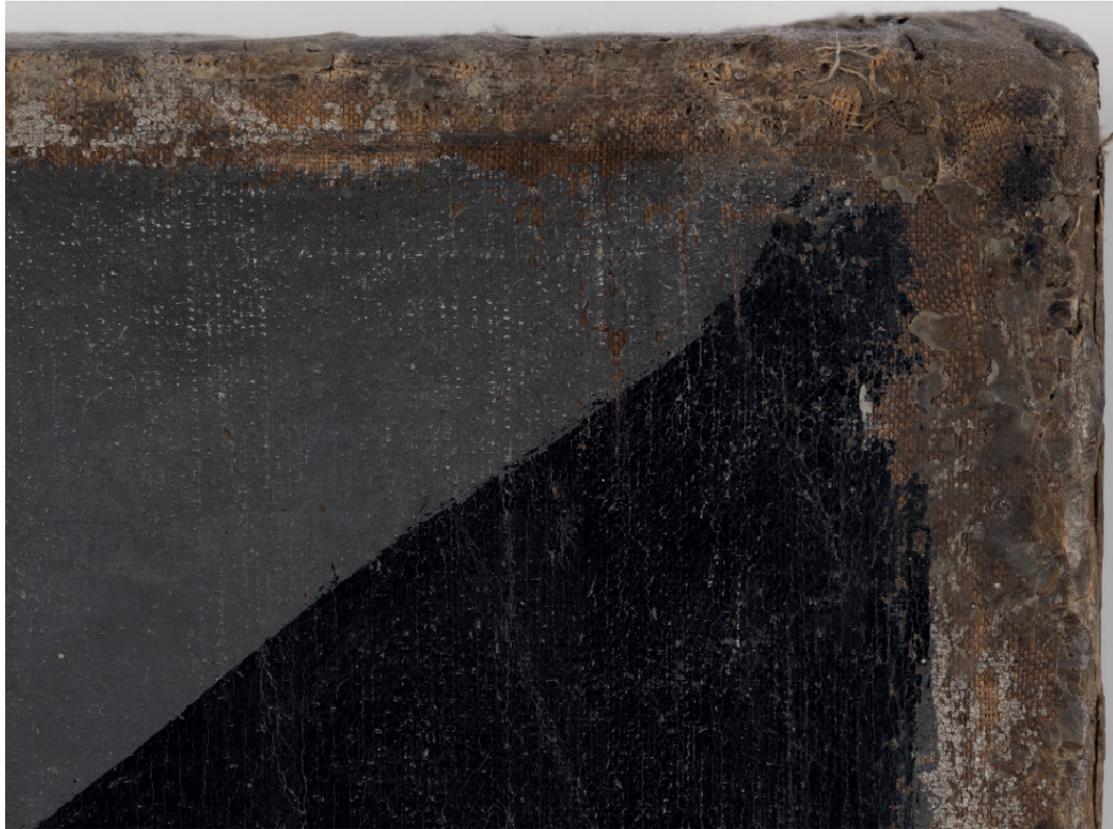
The appearance of the wax-resin follows a set pattern and is revealed in different forms: it is not uncommon to find wax which has seeped through the areas with losses, which means that they completely covered with reinforcement material. Occasionally, the wax goes beyond the loss areas to create yellowish surfaces, to differing intensities. A large part is concentrated on the sides after strips were placed on the outer edges of the canvas (Fig. 14).

Fig. 14. Concentration of wax in the top right corner. In many points, the thickness of the wax is so great that it often appears with strong craquelure and with some dirt stuck to the surface.

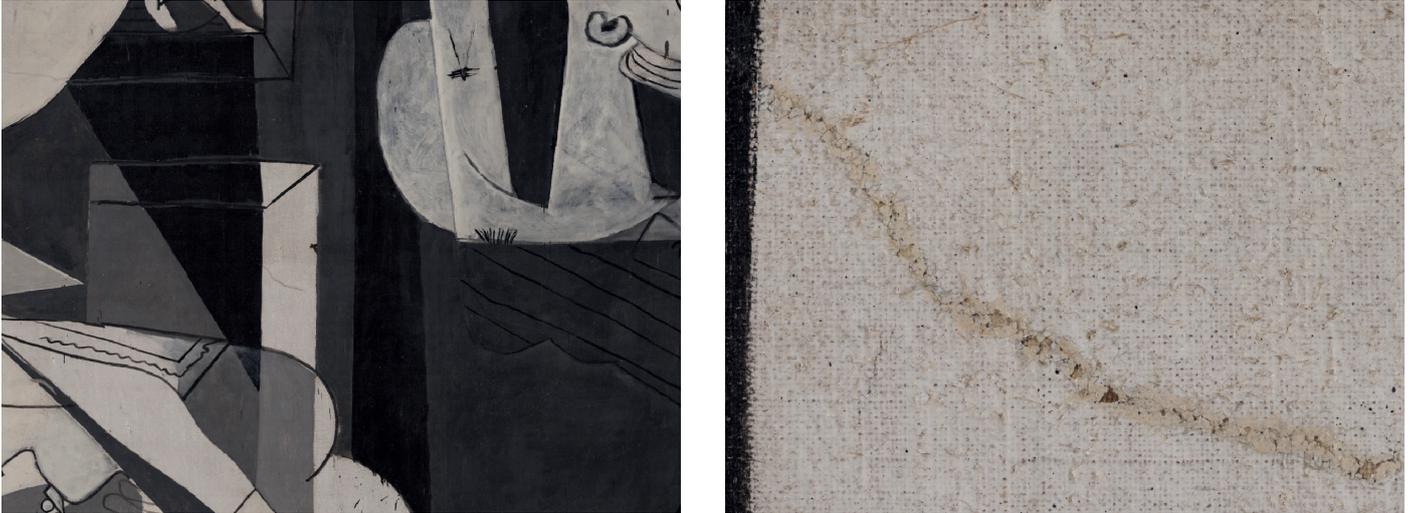
Many of the losses detected in the work were treated previously, as shown by the ample paint reintegration and colour retouching. Many of them can be seen either with the naked eye or with ultraviolet light. In some cases, this reintegration can exceed the limits of the area with media loss and invade areas with the original paint (Fig. 17).

Fig. 17. Reintegration covering the original polychrome. In certain white areas, the reintegration can sometimes be found with light shifts in colour and often exceeds the limits of the paint losses. In the image on the left, an overview, we can locate the large-scale reintegration on the center of the image, on the white part of the window above the woman who enters hastily from the right. In the image on the right, we can see close-up details of the reintegration.

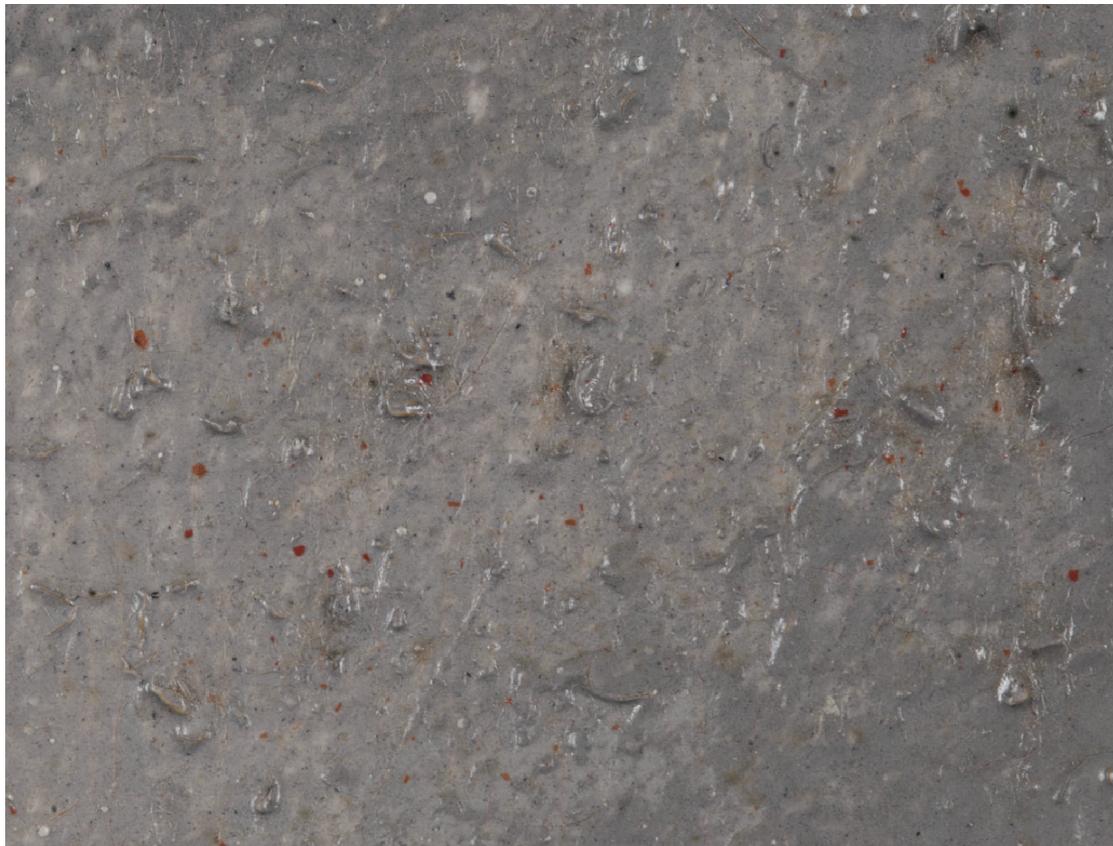
Nevertheless, macrophotographs have enabled us to detect a series of tiny reddish paint residues, virtually imperceptible to the naked eye. In some cases, they can be seen as splashes, and in others, less commonly, they appear as fissures (Fig. 18).

Fig. 18. Tiny dots of red paint residue from the act of vandalism in 1974.

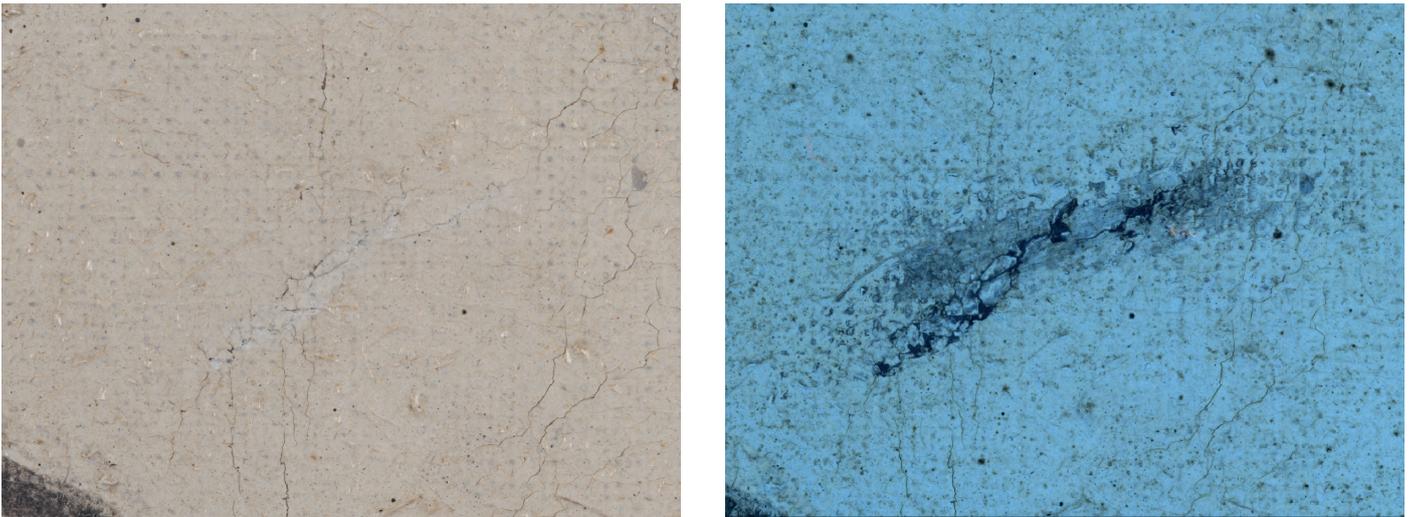
The surface of the work demonstrates colour retouching from different periods to hide deterioration and losses. Given the disparate response to ultraviolet light, paint reintegration was probably carried out at different points and with different kinds of materials. We can differentiate between paint reintegration to cover the losses of media and the repainting that exceeds the limits of these losses. The first ones are in a highly opaque, dark violet hue, whereas the second ones are clearer and more invasive, overlaying the original paint (Fig. 20).

Fig. 20. Comparison between visible light and ultraviolet light. With visible light, the reintegration, in this instance, is almost indiscernible, whereas with ultraviolet light the reintegration and repainting are highlighted. This retouching is found above the horse's knee, located below the woman hastily entering from the right.

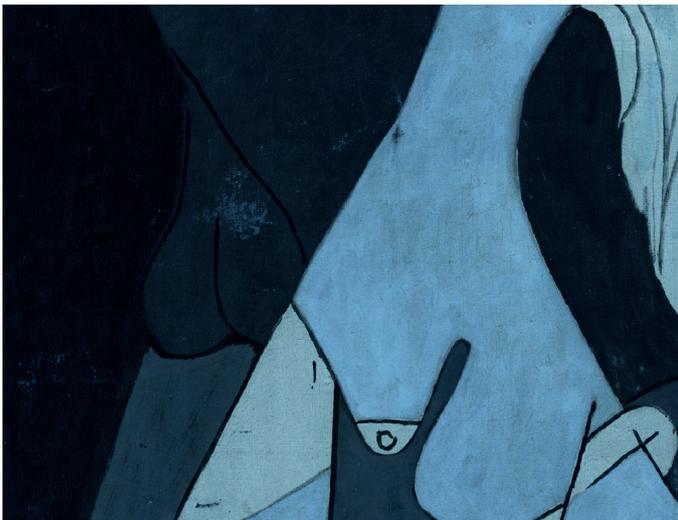
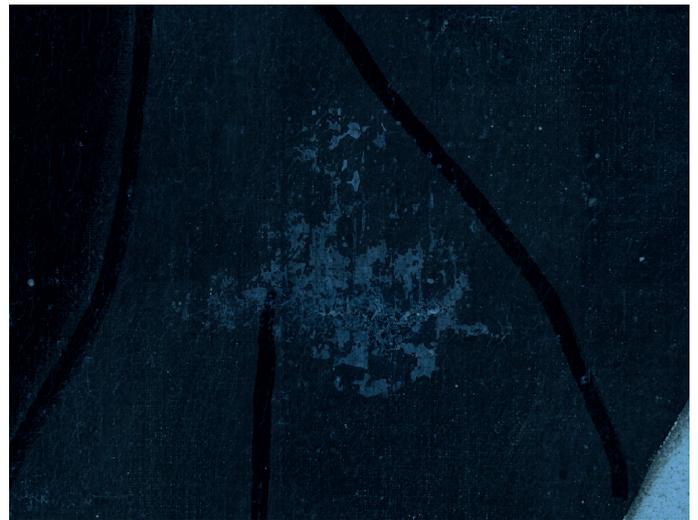
Fig. 22. Wax accumulated on the area of the bull.

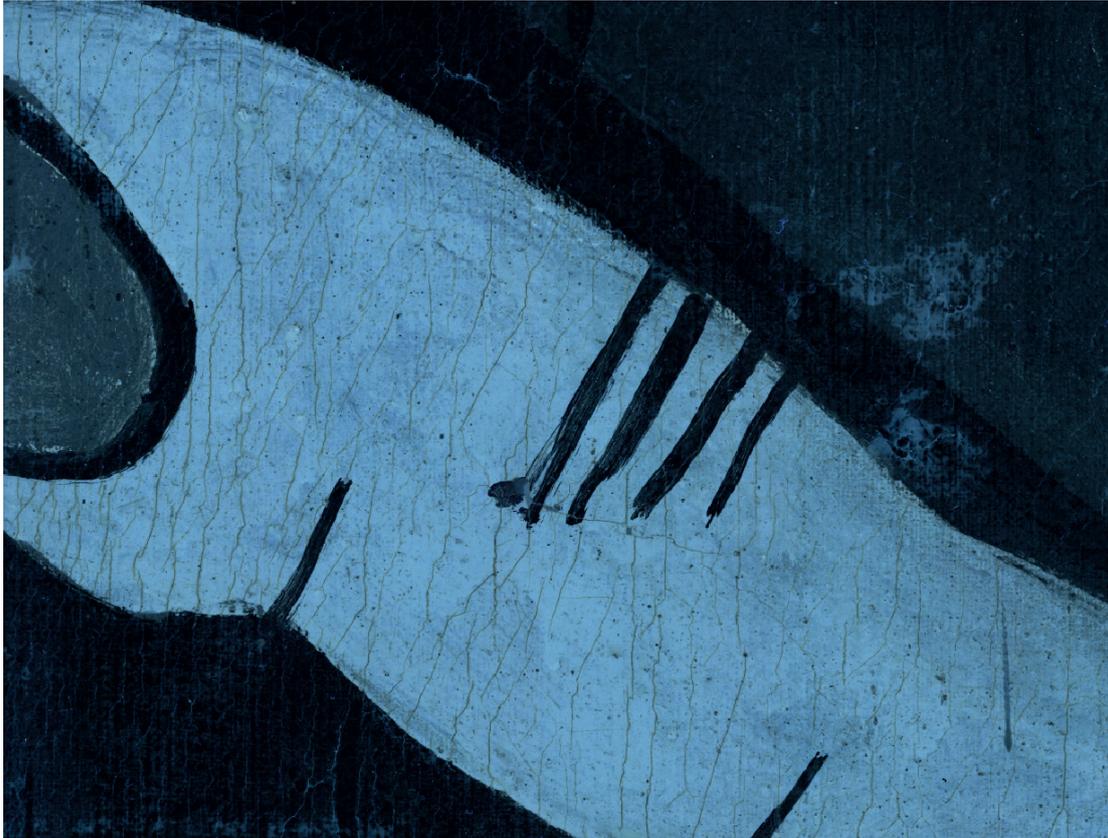
Fig. 23. Wax on the surface of the painting, through the craquelure on the dead soldier's hand.

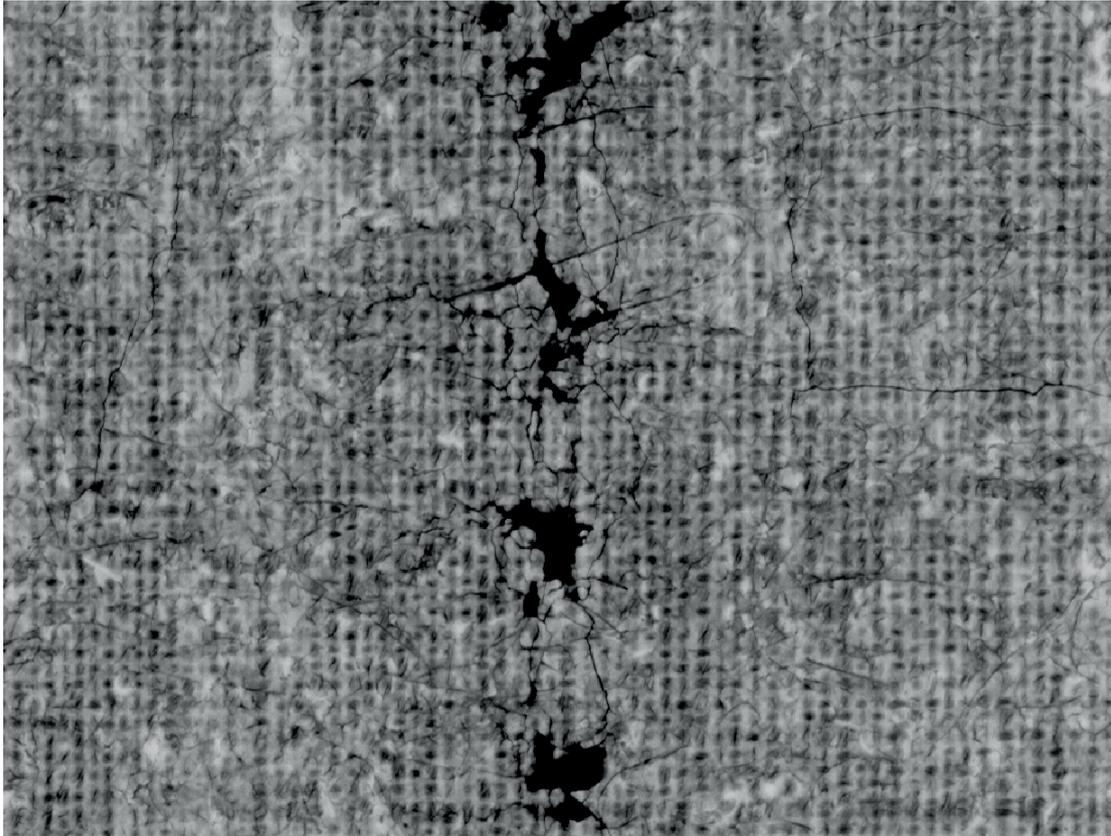
The large number of fissures, craquelure and losses of media appear in highly defined lines and forms, even in dark colours, which are more difficult to make out with visible light, and enable us to study their morphology and the patterns they follow. The losses covered with retouching are seen more clearly than in a study with visible light because they are often hidden by the paint (Fig. 27).

Fig. 27. Details of the losses seen through x-rays. These are found on the horse's neck.

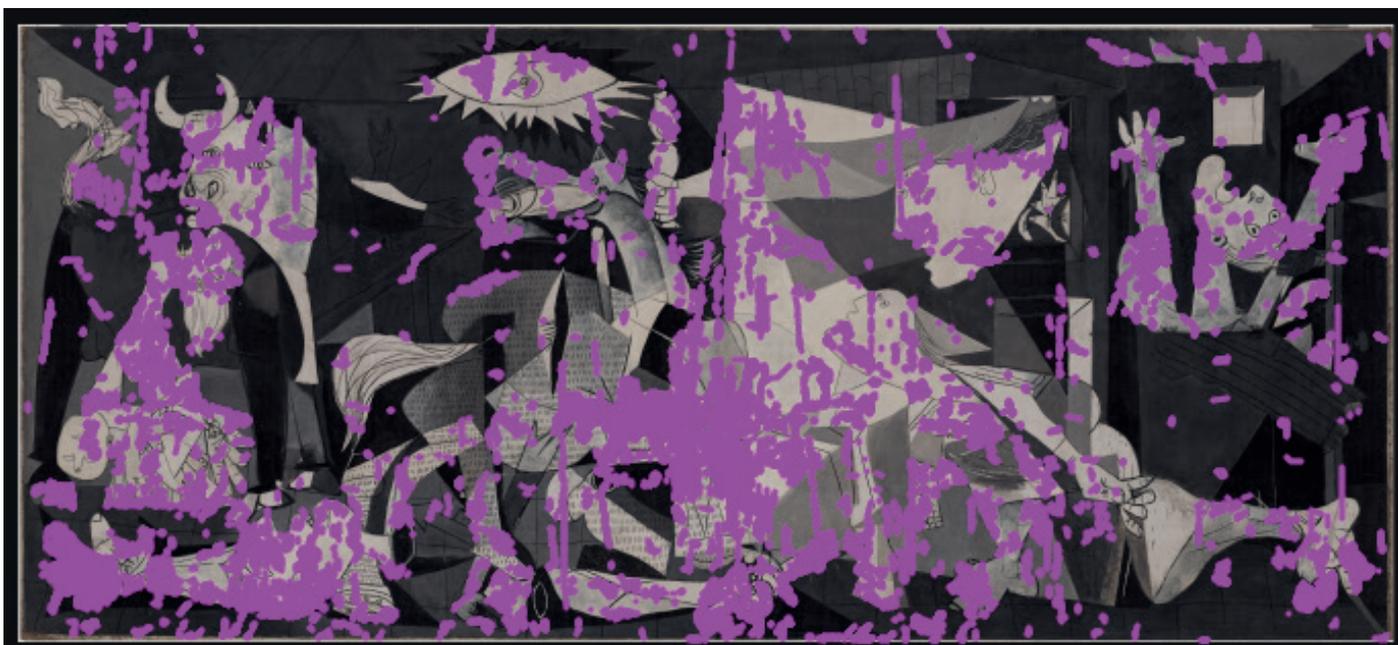
Craquelure detected through visible light:

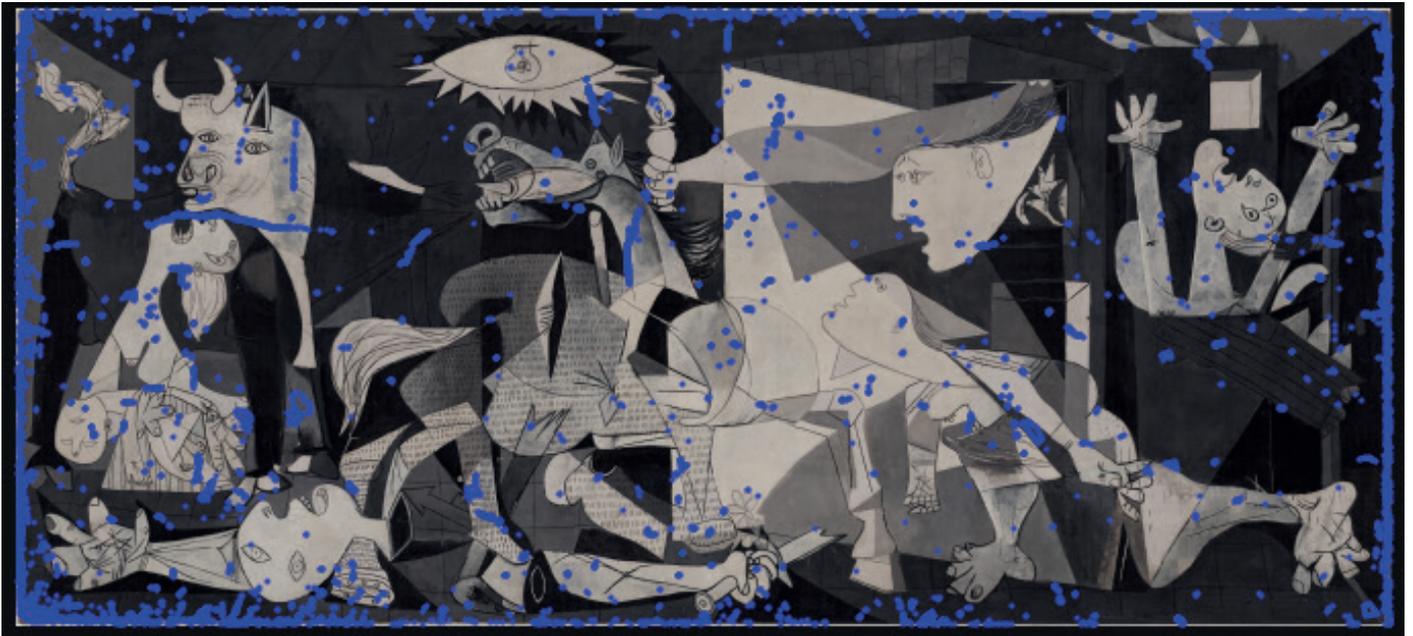
Losses detected through visible light:

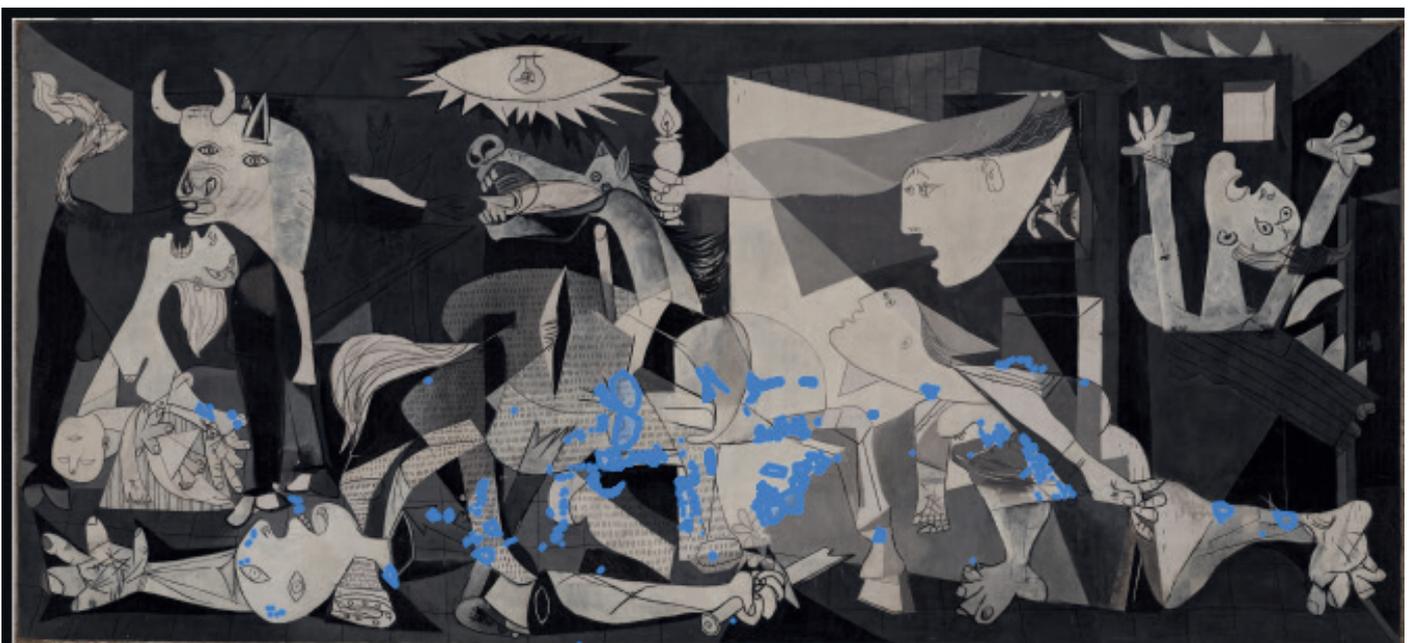
Paint residues from the act of vandalism detected through visible light:

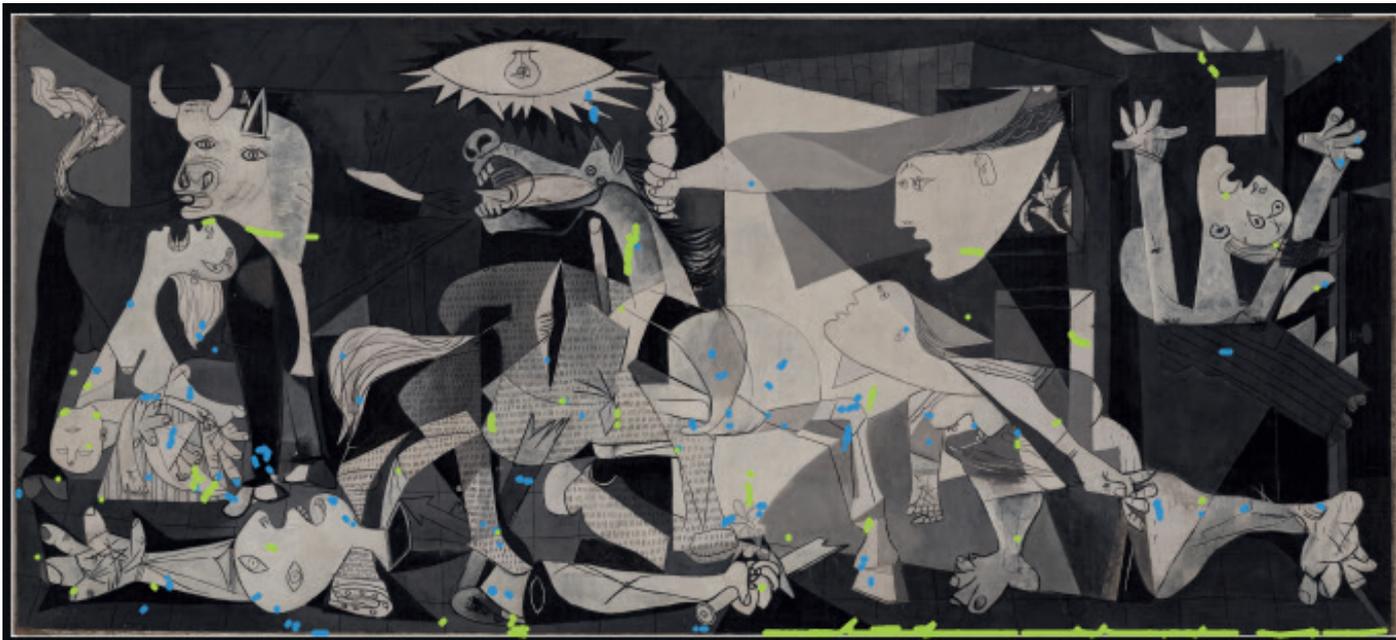
Reintegration and retouching seen through visible light:

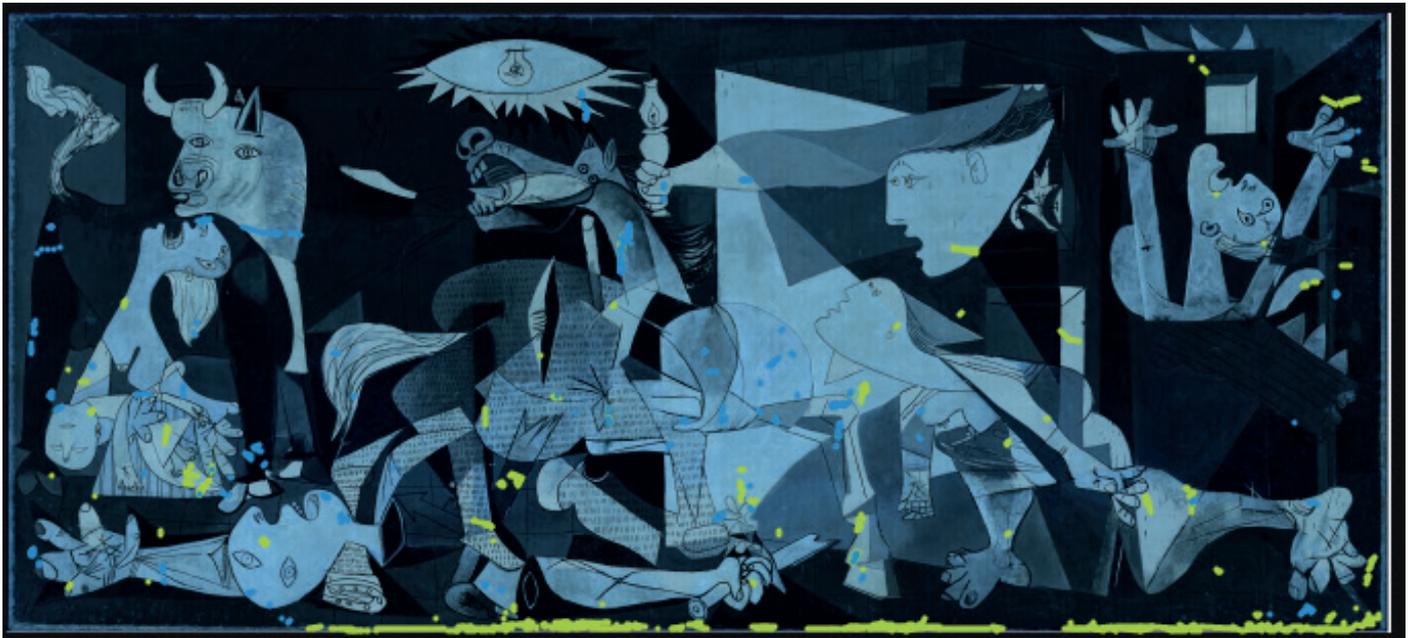
Reintegration and retouching seen through ultraviolet light:

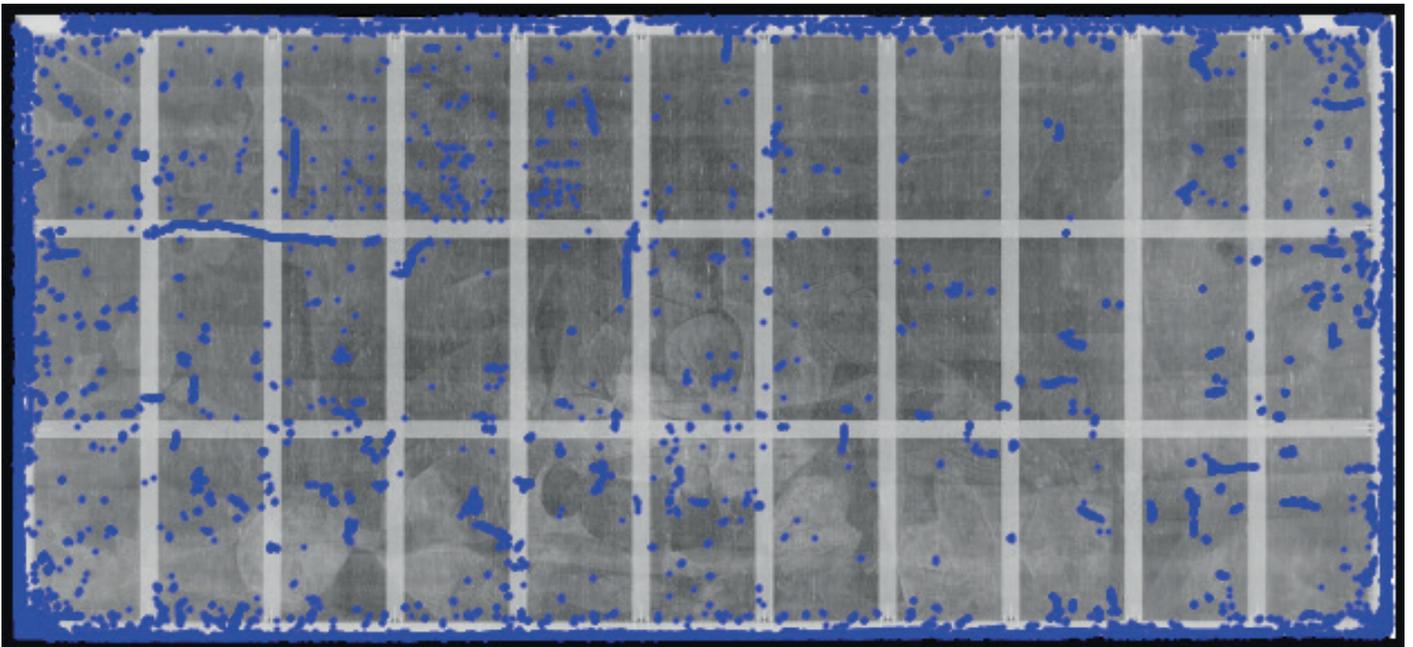
Losses seen through x-ray imaging:
