Guernica
Pablo Picasso
Technical Studies
Conservation–Restoration Department

Guernica

Technical studies

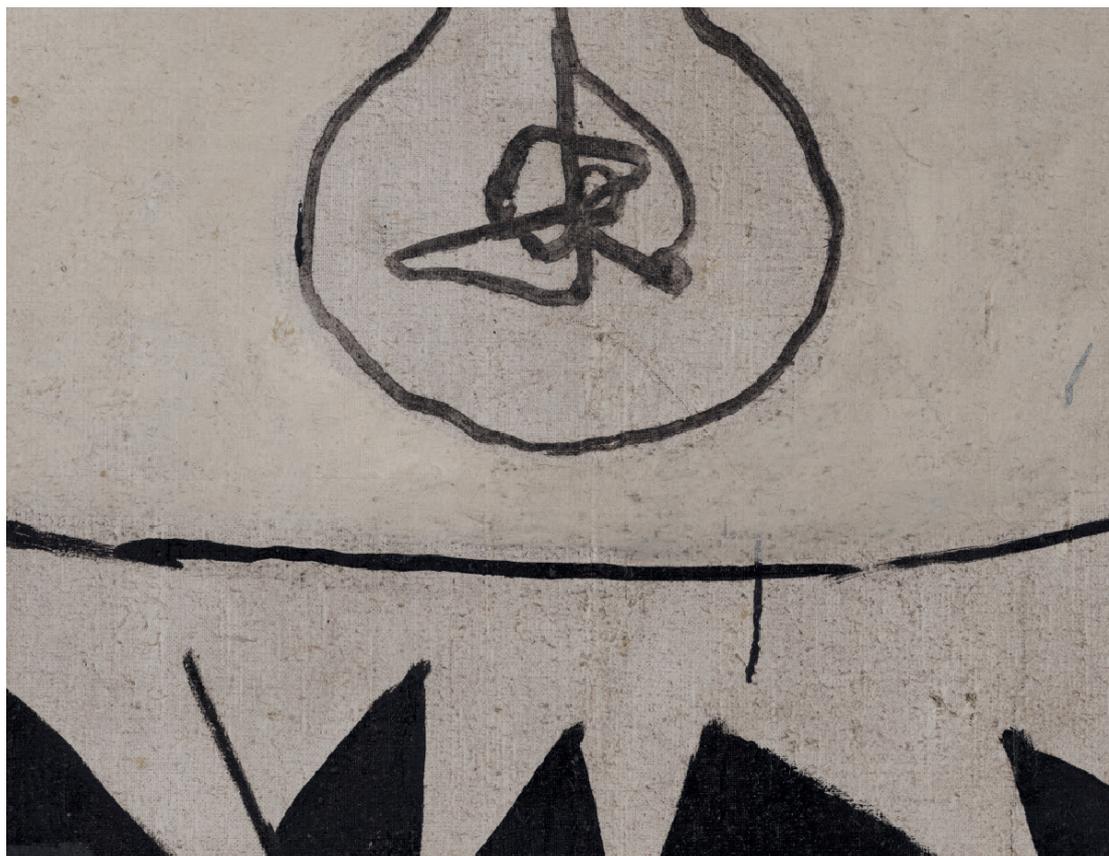
In some cases, the ground layer forms part of the composition, and Picasso left it exposed in certain figures. It is precisely in these areas where details of the weave of the fabric can be discerned (Fig 1).

Fig. 1. Some of the areas where the ground layer forms part of the composition.

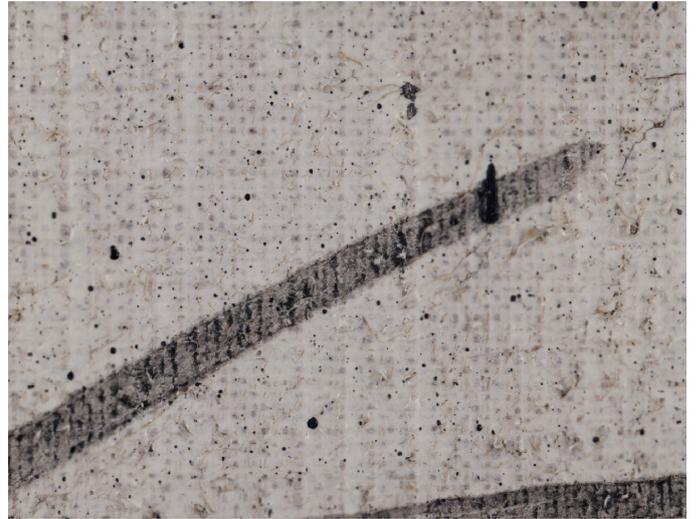
In the area of the horse, specifically, these splatters appear in the form of different-sized black drips (Fig. 2). In the same figure, run-offs can be seen in the jaw area, demonstrating the artist's fluid technique in certain points (Fig. 3).

Fig. 2. A close-up of the black splashes on the horse's tail.

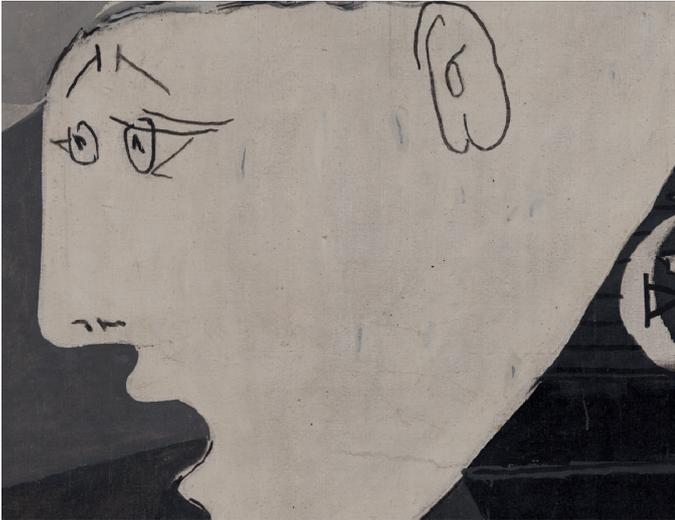
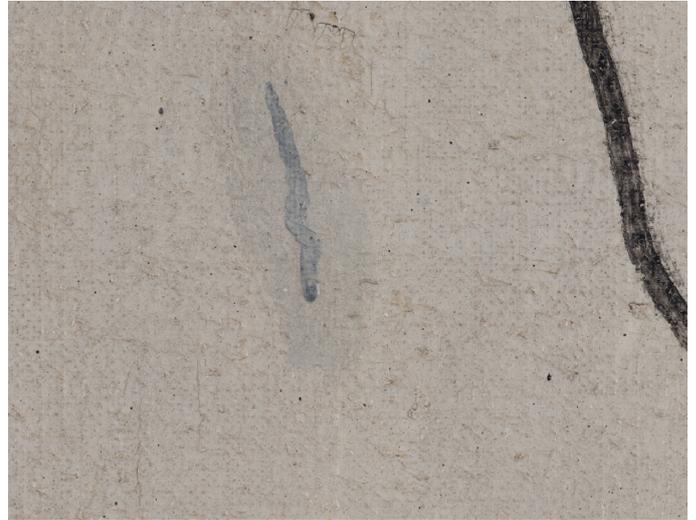
In specific areas, the naked eye can observe brushstrokes or precise, underlying details, veiled with thin layers of paint. One such detail illustrating this technical resource is related to the face of the woman in the window, in which black paint runs off and has been deliberately covered by the artist with a fine layer of paint; a layer so thin that with the naked eye we can see Picasso's rectifications (Fig. 4).

Fig. 4. Black splashes of paint covered by Picasso on the face of the woman in the window.

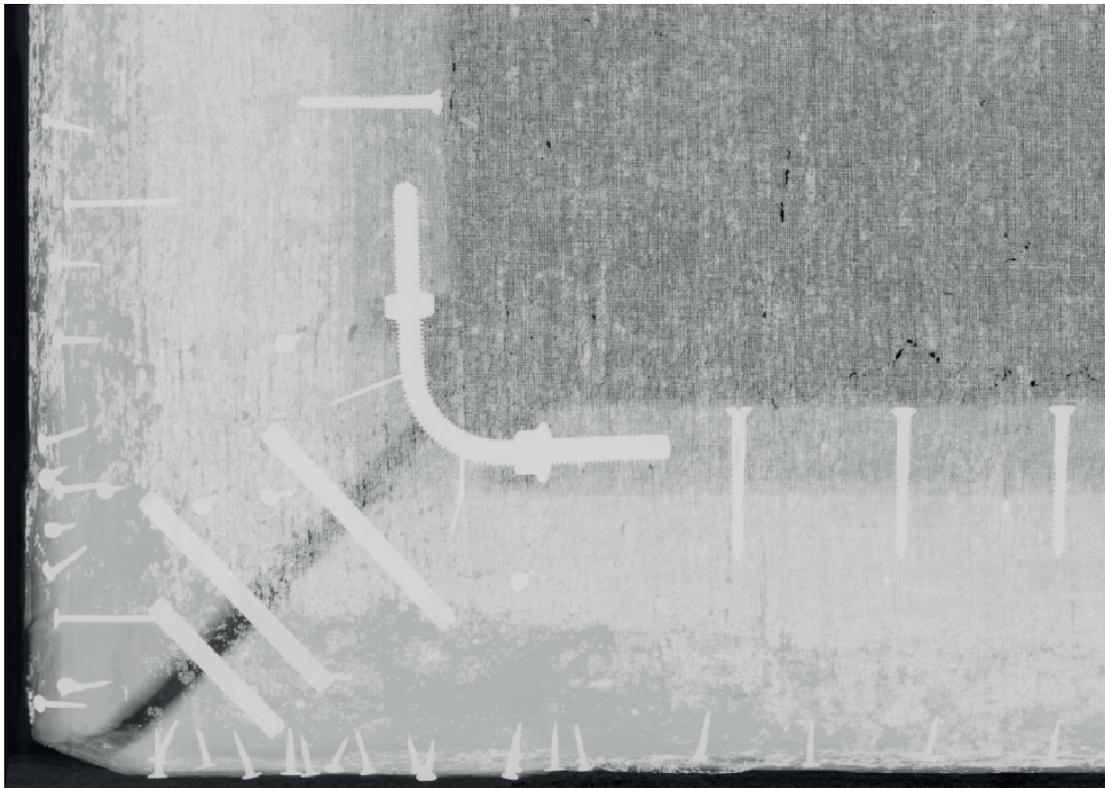
On the perimeter, the canvas is tacked down, although at some points there are also nails of differing lengths.

Fig. 25. Close-up of the bottom left corner where the screws, the tacks and the nails holding the canvas in place on the stretcher can be seen.

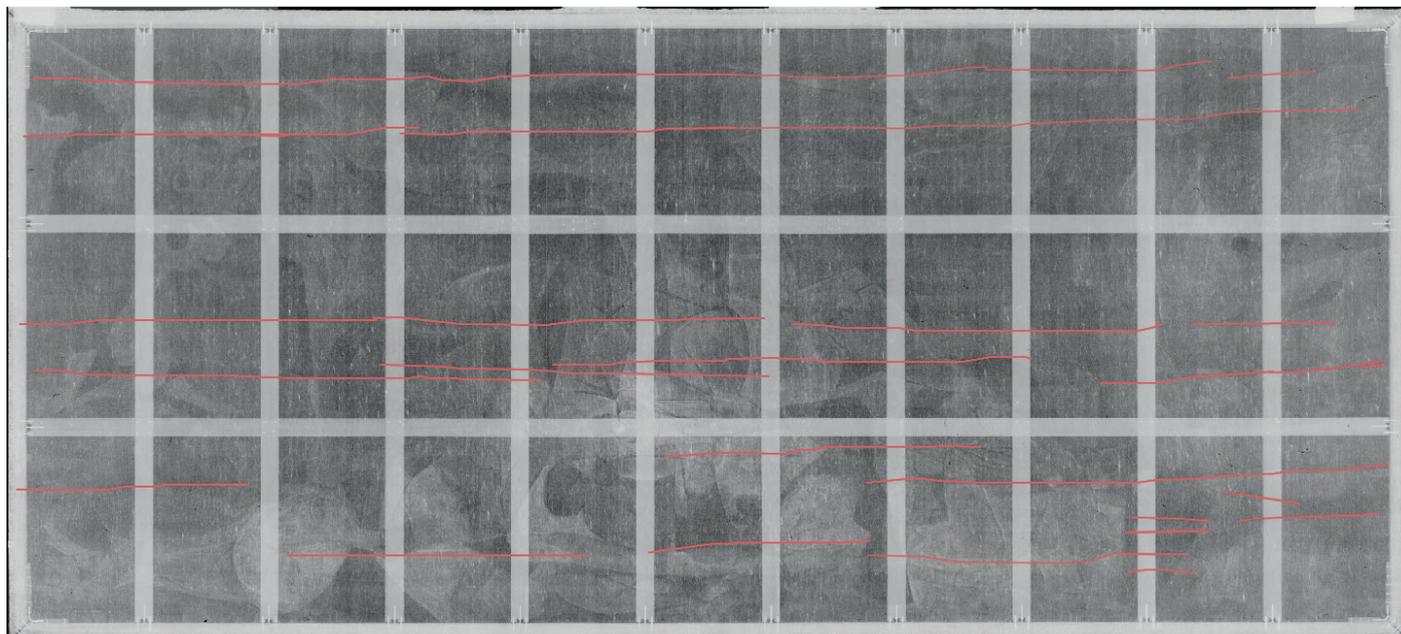
In the x-ray, we can see a series of broad horizontal strokes, which possibly correspond to the those produced when spreading the ground layer on the canvas (Fig 29).

Fig. 29. Diagram of the movement of the horizontal strokes discerned in the x-ray of Guernica and identified as the application of the ground layer.

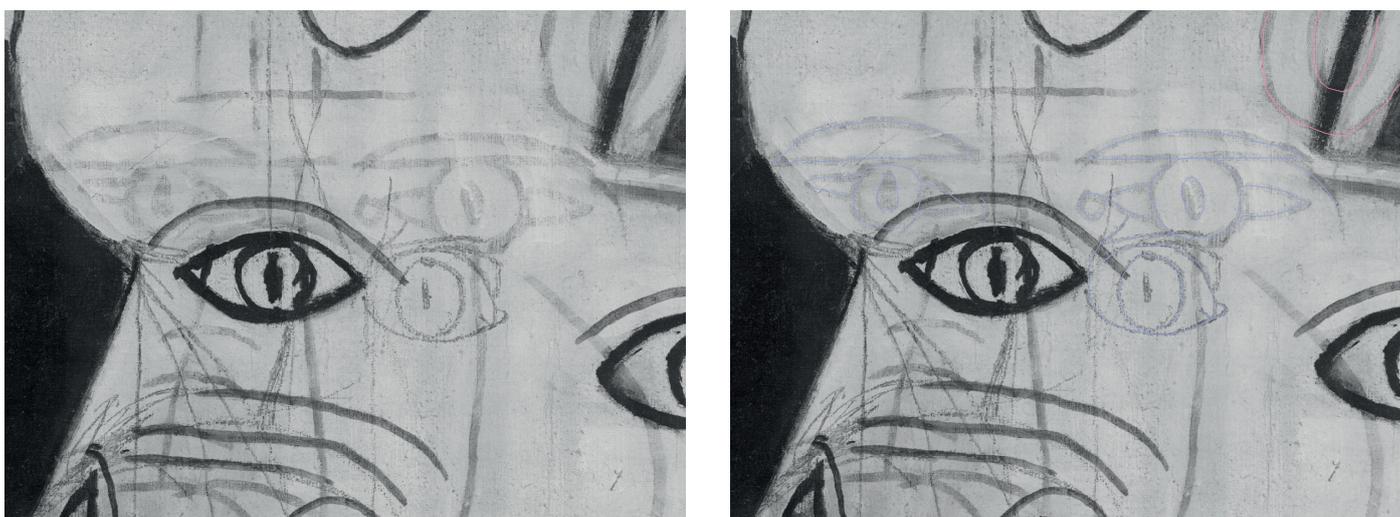
Therefore, in the image obtained with infrared technology we can see the different eyes on the bull's head, some of which are hidden by a layer of white paint covering them. They do not correspond to those seen in Dora Maar's photographs, but rather to an intermediate stage, possibly situated, temporarily, between photographs 5 and 6 (Fig.50).

Fig. 50. A close-up of the different eyes on the bull's head.

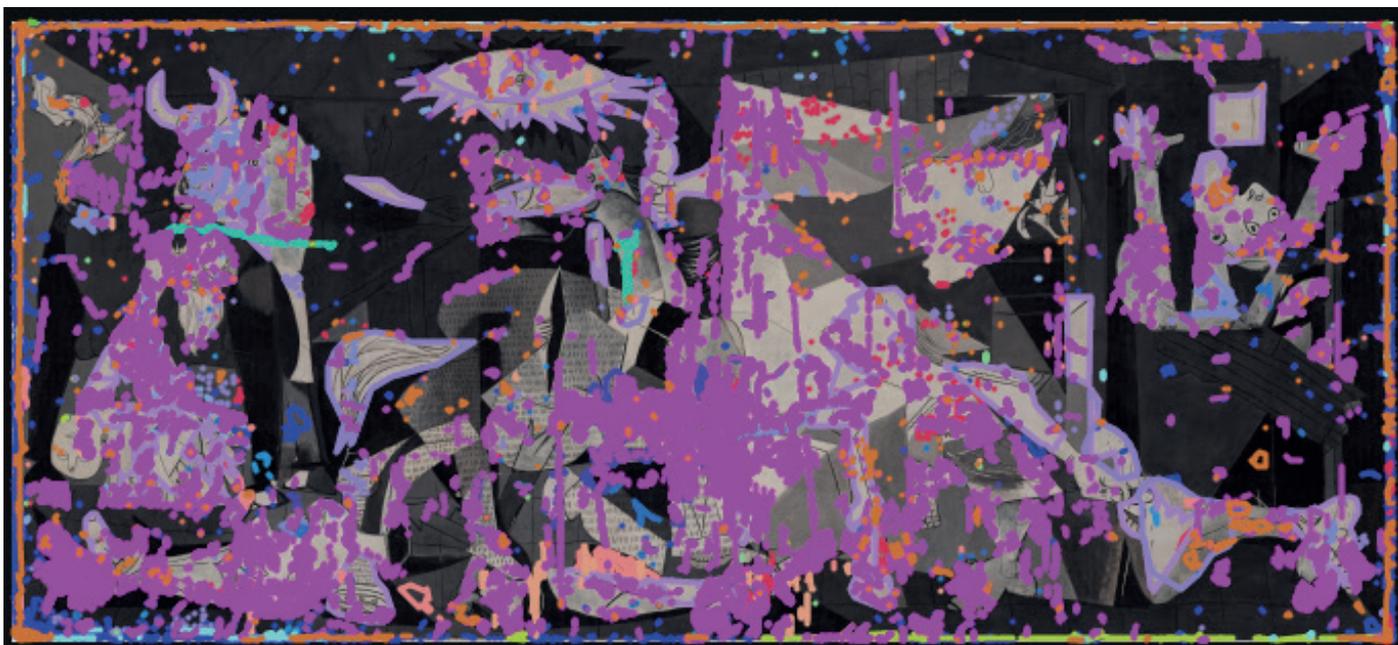
The result of visible imaging with all alterations and technical data:

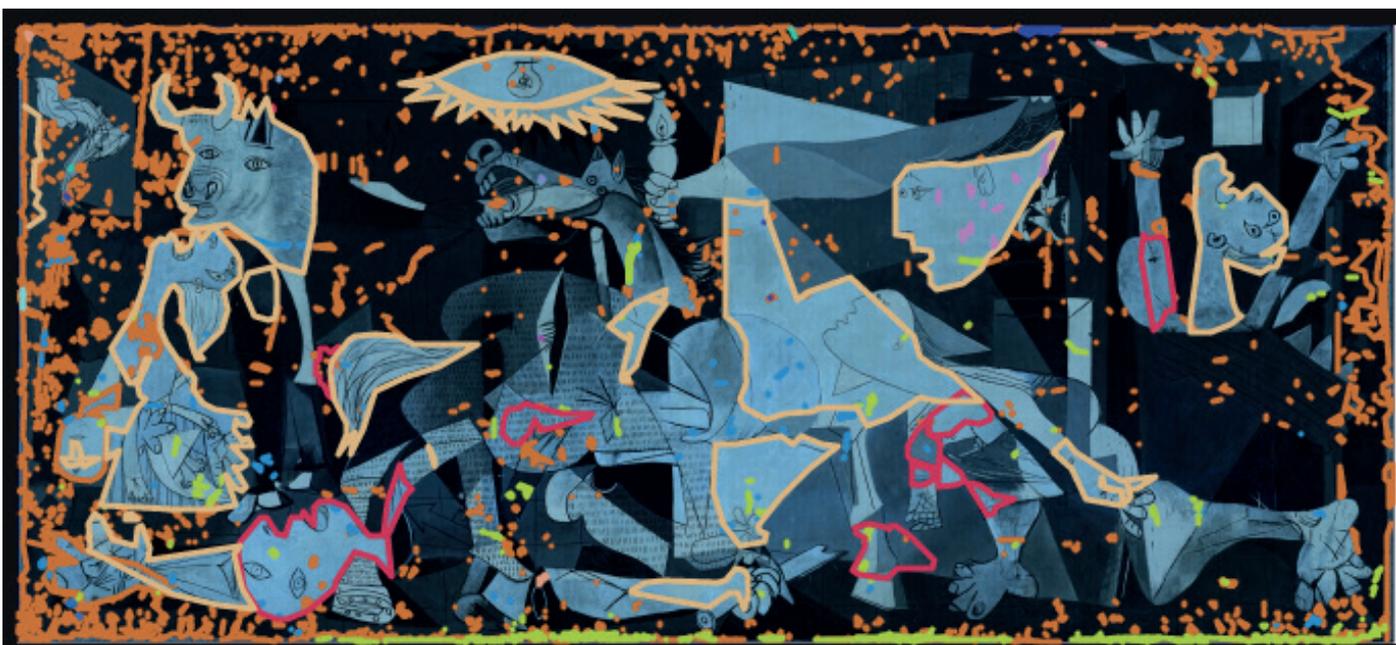
The result of ultraviolet imaging with all alterations and technical data:

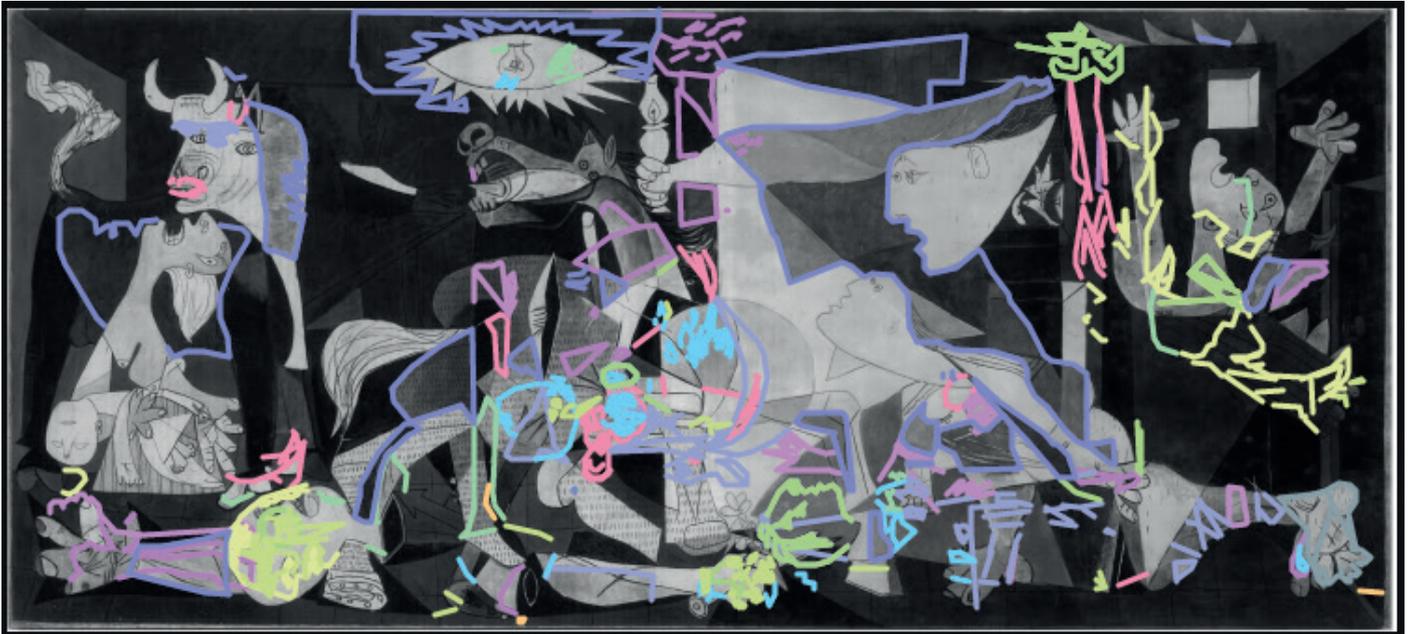
The result of infrared reflectography with all alterations and technical data:

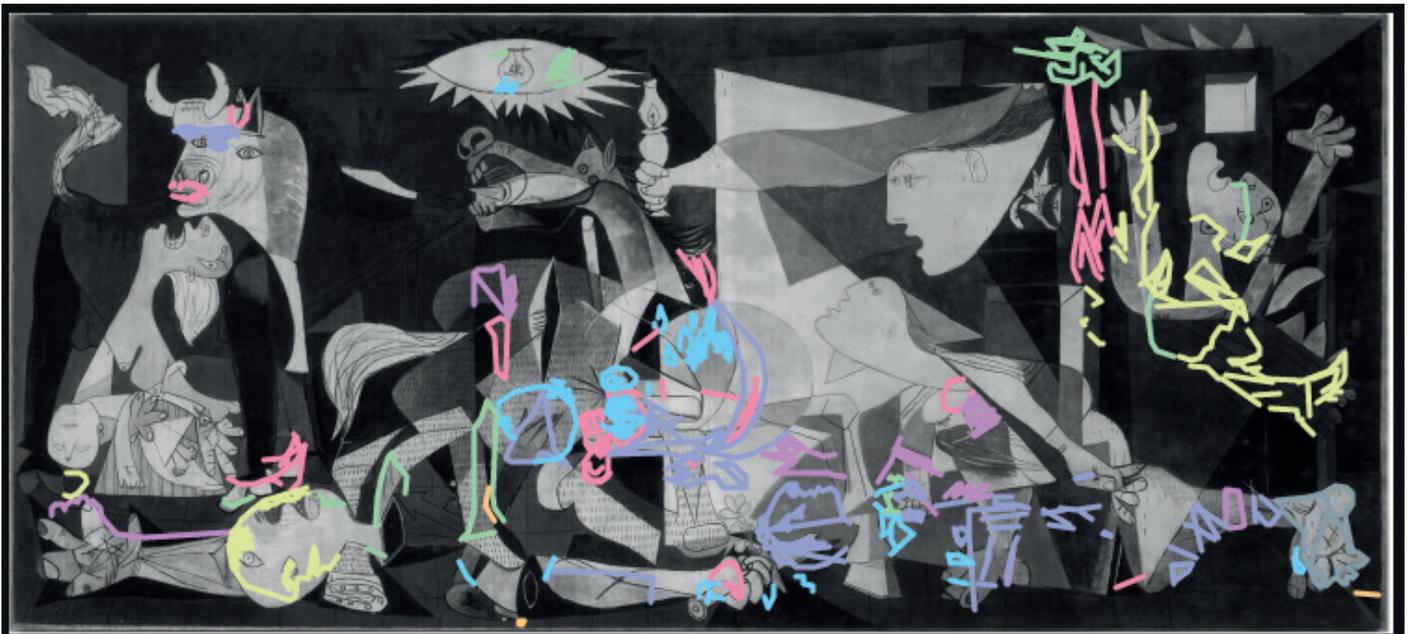
Compositional changes seen under infrared reflectography:

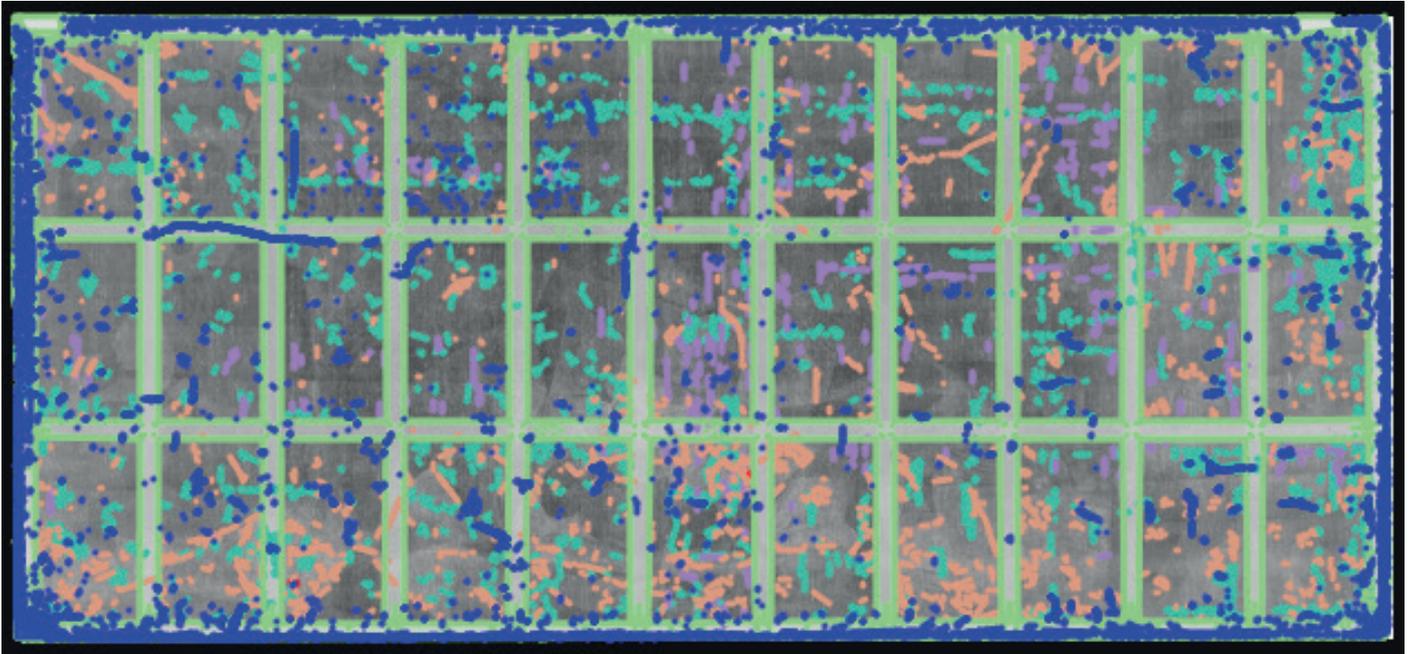
Result of x-ray imaging with all alterations and technical data:
